Analysis of Side Underride Crashes
Part 1 – Misconceptions and The Problems
By Angela Trego, PhD, PE, Bruce Enz & Douglas Head, PE

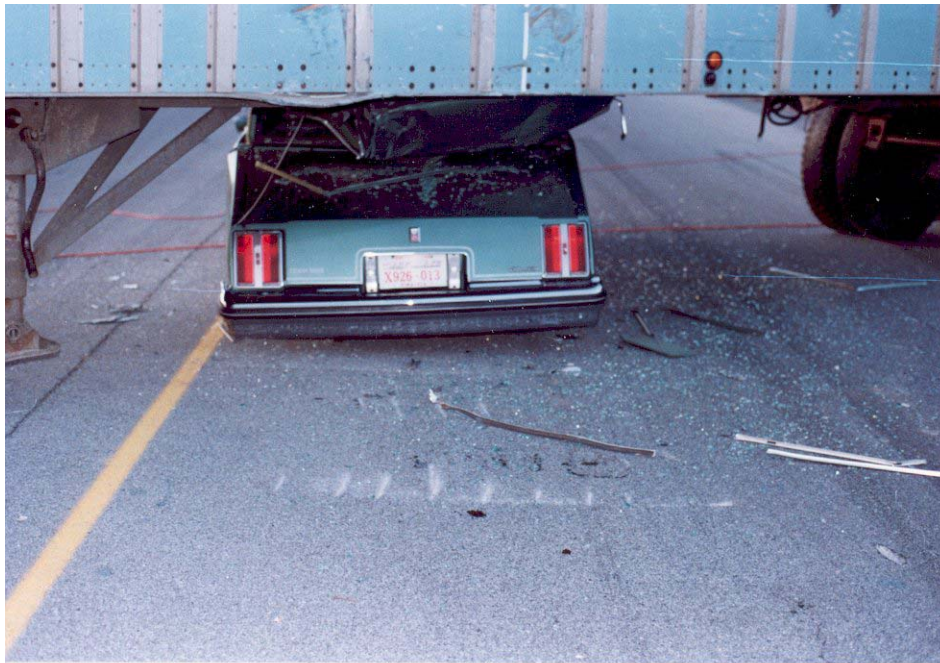
The distance from the gouges to the edge of the trailer is approximately 8 to 12 feet. This is generally carried over from the investigator's experience with typical crashes, where the vehicle front undercarriage may be forced downward, which often results in gouges in the road surface. Contrarily in an underride collision, the front of the car is typically lifted up during the initial stage of the underride, as the roof panel begins to offer resistance during the early deformation period of the crash. This causes the rear of the vehicle to angle downward. Depending upon the rear overhang of the vehicle and ground clearance to the bottom of the bumper and other undercarriage components (tie down hooks, mufflers, tailpipes etc.), these components or the rear bumper can also contact the road surface leaving scrapes and gouges. It is these gouges that are commonly misinterpreted as frontal component gouges from downward compression of the vehicle

undercarriage during the crash. There have even been instances where the investigating officer or accident reconstructionist misconstrues the gouges as originating from the trailer as it is supposedly sliding sideways.

When the investigator then measures from the gouges to the trailer after the accident, he has established the plane that the contact edge of the trailer occupied as it supposedly forced the car downward. This then becomes the distance that the trailer 'moved laterally' and is inserted as a distance variable for post crash speed calculation, which is used in the momentum formula. This improper initial speed reconstruction approach typically over estimates the speed of the vehicle as it collided with the trailer. Depending upon the weights and the calculated post impact speed, the over estimation can be a large magnitude. From time to time the reconstructionist will consider rotation points for the trailer and then calculate the impact speed. This can result in errors that are either greatly overestimated or underestimated.

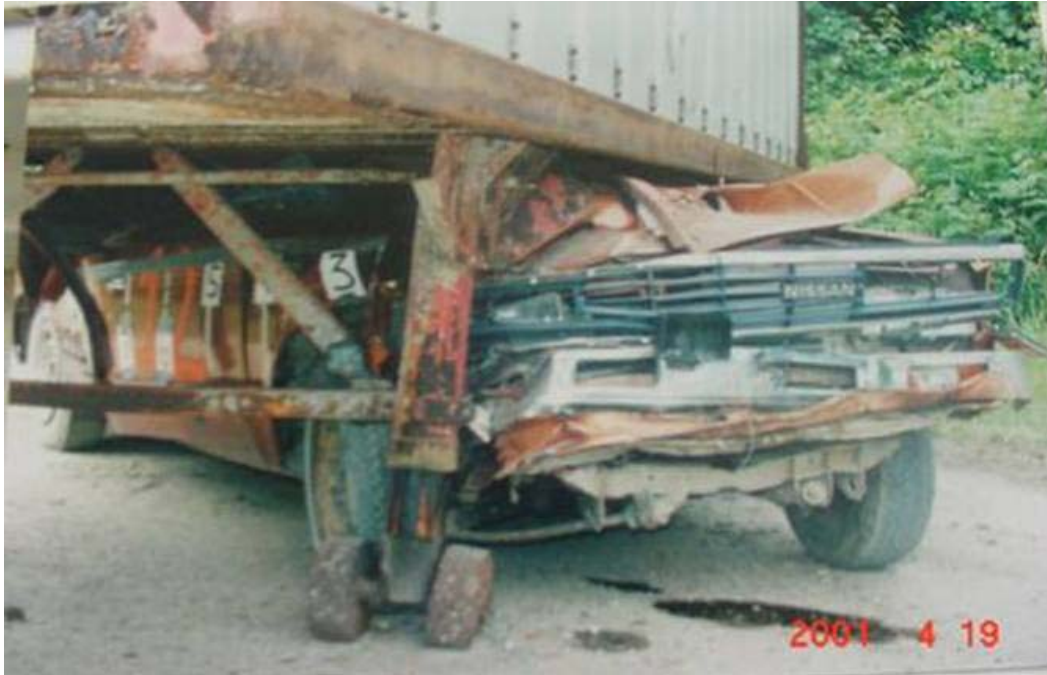
Each of these components is different in nature. They are designed for totally different uses, which means that they deform in different ways when involved in a crash. When doing speed analysis of an underriding vehicle that has been damaged by and caused damage to these types of components, the damage to the underriding vehicle and to the component(s) must be assessed. For example, a simple underride bar or tire hanger cage offers very little resistance to a vehicle that strikes them from the side because they were not designed for lateral loads. The damage may vary from the components connections to the trailer simply separating to twisting and bending.

The damage caused to a vehicle contacting these components varies in location and pattern. The impact damage is narrow when striking the trailer dollies and it is wide when striking the dual tires and wheels. It may be limited to the side panels of the vehicle or the outer metal panels of the hood or trunk. The peeling of outer sheet metal and contact to 'hollow' points on the vehicle do not slow the underriding vehicle down to

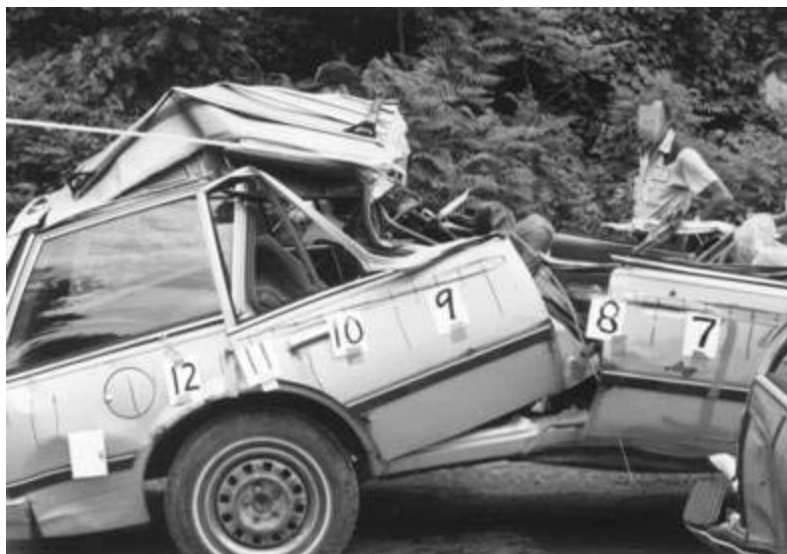
Vehicles with strong vertical members at the B, C or D pillars can cause the vehicle to bend at the rocker panel attachment point at the base of the respective pillar. This has been termed 'bend down'. The "bend-down" condition was noted on several of the crashes and occurred as the forces were transmitted down the vertical member of the central and rear pillars to the rocker panel. The large moment arm of the central and rear pillar caused the rocker panel to deform at the base of the lower B pillar. The upper part

of the B pillar shifted rearward causing the entire rear of the car, rearward of the pillar, to bend downward.
