FIBER OPTICS IN BONDED REPAIRS

Angela Trego, Ph.D., P.E.
Russell Keller
The Boeing Company
PO Box 3999 MS 84-09
Seattle, WA 98124-2499

ABSTRACT

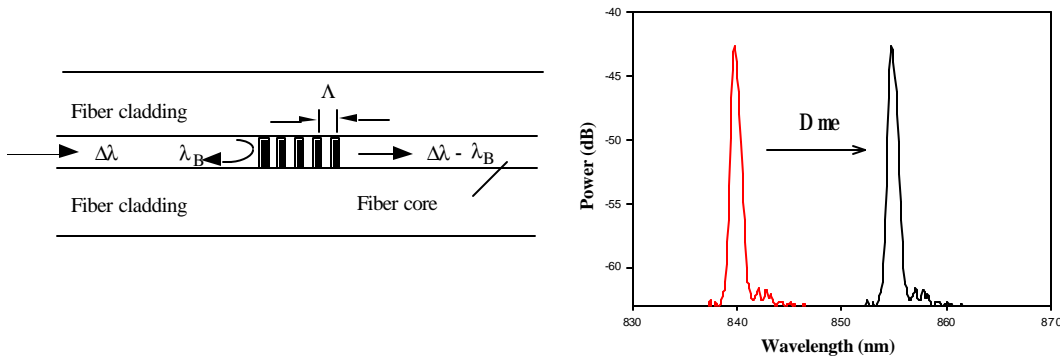
a) Refractive index variation within the core b) Spectral shift with induced strain
Figure 1. Schematic of the Bragg Grating Sensor

As shown in figure 1a, the photo-induced planes of constant index of refraction will be oriented perpendicular to the axis of the fiber. In this configuration, part of the light incident on the grating gets back reflected while most of the light will be transmitted. The reflected wavelength, λ_B , will interfere constructively after reflecting off each of the layers, satisfying the Bragg equation relationship:

1.1 Sensor Design Photo induced Bragg gratings were first demonstrated by K.O. Hill et al. in 1979 [2] using light from an argon-ion laser. Currently, the optical fiber Bragg grating is fabricated by exposing UV light through a phase mask onto the optical fiber. This fabrication process offers the capability of maintaining the pristine ultimate strength of the optical fiber by recoating Bragg grating sensors with a protective polymer after the writing process. Inherent advantages that optical fiber Bragg grating strain sensors have over the foil strain gauge include size and flexible geometry, resistance to EMI, sparks, and most chemicals, and allowance for inexpensive distributed sensing capabilities. As opposed to the foil strain gauge, the Bragg grating strain sensor operates on self-referencing absolute measurements. This allows the user to unplug and plug into the sensor at time-based intervals without having to recalibrate. The resulting sensor element is illustrated below, in figure 1a, along with the optical spectrum shift with strain in figure 1b.

where P_E is the photo elastic constant for the silica fiber core. Hence by tracking $\Delta\lambda_B$, residual strain can be accurately monitored. Figure 1b illustrates strain measurements using the spectral shift from a Bragg grating.

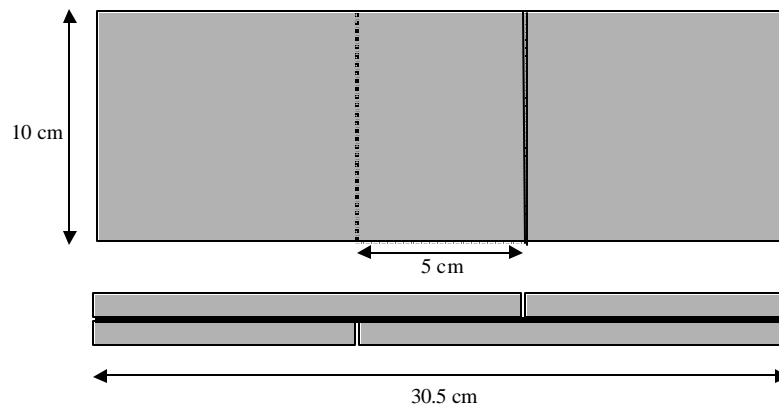
Figure 2. Single Lap Shear Specimen Configuration

two 1.6 mm (0.063”) thick aluminum (7075-T6 and 2024-T3 alloys) panels, assembled such that a “stabilized” wide area single lap joint of the two panels was created. Figure 2 illustrates the specimen configuration. The lap joint was 10 cm (4 inches) wide by 5 cm (2 inches) long for two primary reasons: 1) the extended width provided a large bonded area around the sensor that would correlate to the area in a bonded doubler situation, and 2) to accommodate an easier installation of the fiber optic sensor in the joint. Unlike previous efforts at installing fiber optic sensors where the fibers were installed across the joint, these sensors were placed in parallel to the load direction. The sensors were installed in the longitudinal center of the joint (for “C-x” labeled specimens) and at the longitudinal edge of the joint (for “E-x” labeled specimens). Figure 3 shows the sensor installation locations and figure 4 shows pictures from the specimen fabrication.

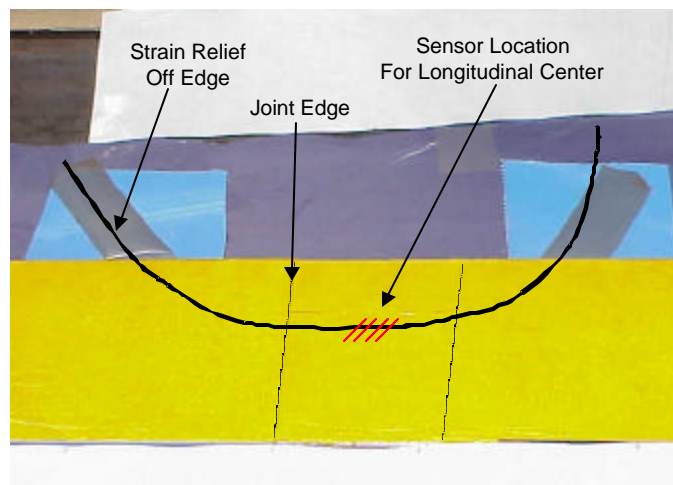
Figure 3. Fiber Optic Strain Sensor Orientation and Locations

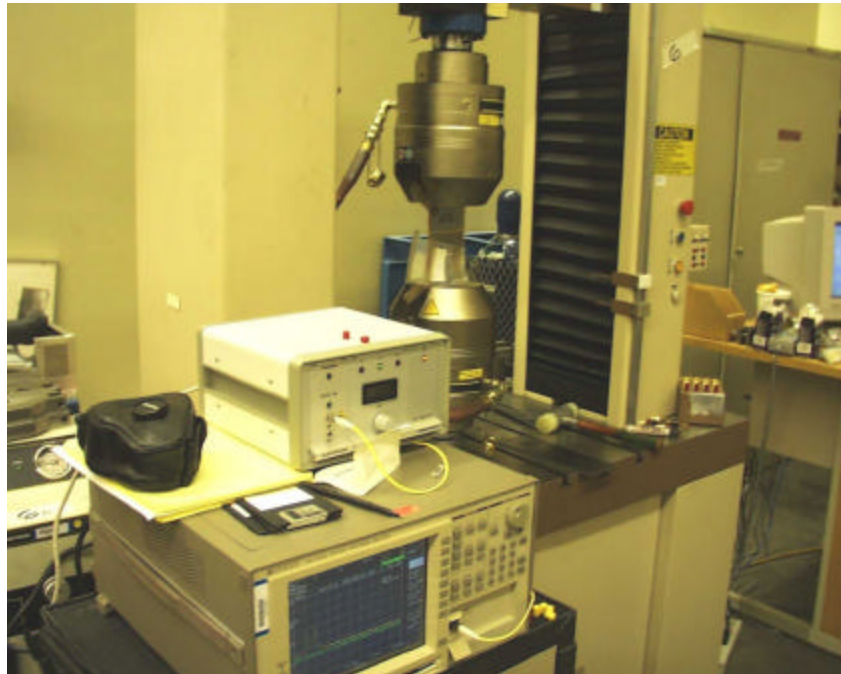
The specimens were tested in the load frame shown in figure 4. Load and head displacement data was collected throughout the test. Load control vs. a head displacement rate was used in order to take sensor readings at specified applied load levels periodically. An optical spectrum analyzer (OSA) was used to record the sensor data. After the specimen was aligned in the grips, an initial reading of the sensor data was obtained. The grip pressure was then applied and another sensor reading was taken to ensure there was no adverse affect or shift in the sensor reading due to the grip pressure. Additional sensor readings were taken at specified load levels. The loading was temporarily halted (approximately one minute) for each reading.

Figure 4. Test Set-up with OSA for Sensor Data Recording

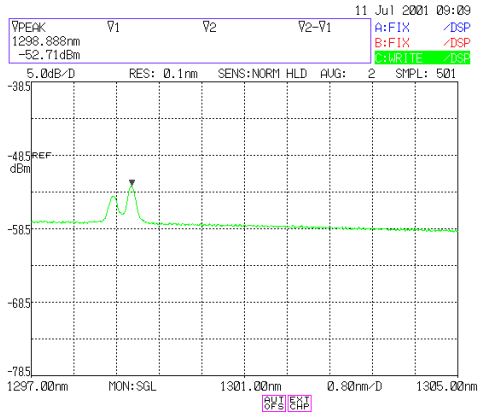
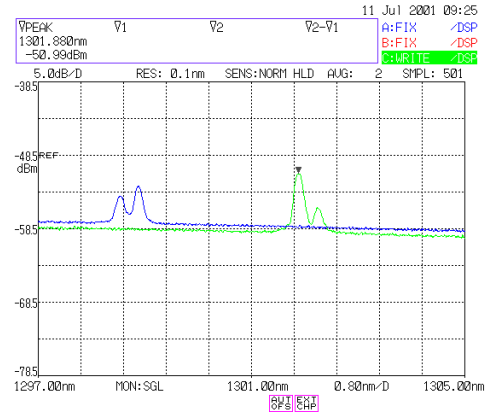
Data could be obtained from each specimen. Changes in the sensor data could be seen real-time by displaying the initial wavelength output as a phantom curve on the graph. Then, as new readings were taken and recorded, the shift in the wavelength peaks could be observed on the OSA screen. Figure 5 shows a typical screen display of the initial response and the shift at the recorded load.

Initial Data Before Load Applied

Wavelength Shift Under Load

Figure 5. C2 Coupon Sensor Data Recorded Before and During Loading

The wavelength output from the sensors indicates relative strain measurements. As can be seen, the data shows a strong shift to the right as well as a change in peak magnitudes. The peak magnitude changes only mean that the polarization is being affected, but does not effect a wavelength-based measurement. The correlation between axial strain and wavelength change is the Bragg equation, equation (2), which relates the Bragg wavelength and wavelength shift to a constant times the strain. The photo elastic constant for these fibers is not available at this time, but will need to be obtained in order to make use of the recorded data for structural evaluation.

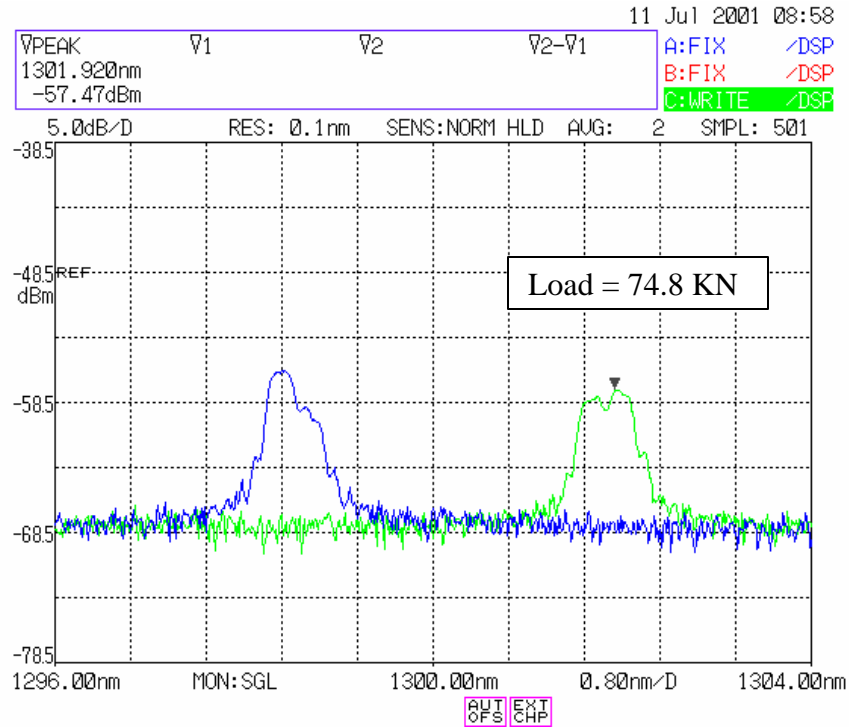
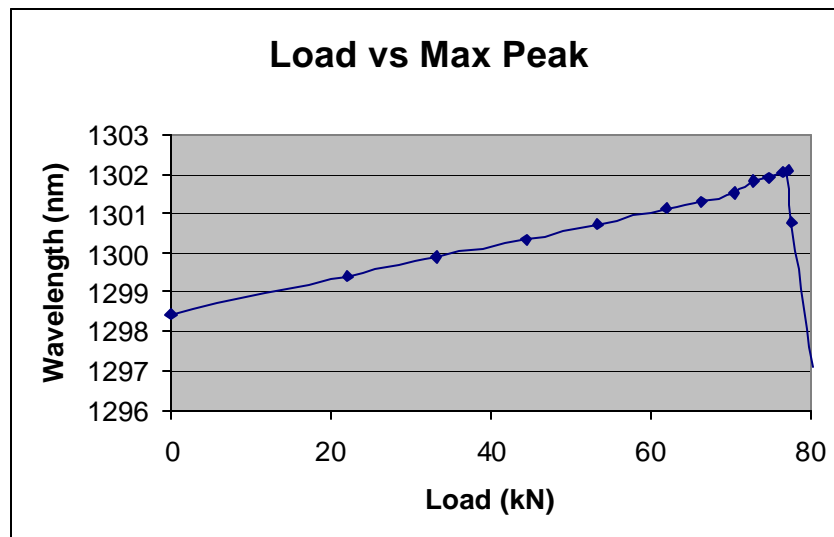
Figure 6. C1 Wavelength Output and Load vs Max Peak

Figures 6 and 7 contain data outputs from the sensors installed in coupons C1 and C2 respectively. A representative plot of the wavelength shift during loading is shown, wherein the original wavelength output is overlaid onto an output recorded during loading. The data recorded from the axial sensor (figure 6) shows the wavelength shift in the peaks. Figure 7 of the bi-axial sensor records two wavelength peaks. As can be seen in this sensor, the separation of the two peaks did not change much for either the C2 or E2 sensor. It is interesting to note that the maximum amplitude of the two peaks for both biaxial sensors switched from the right peak to the left peak as the coupon was loaded, however, this phenomenon is not significant to strain correlation.

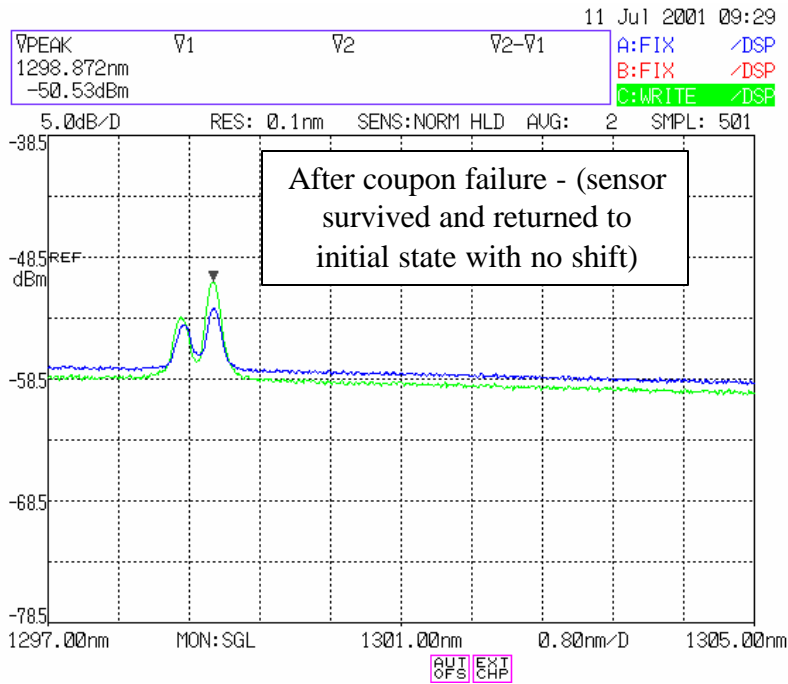
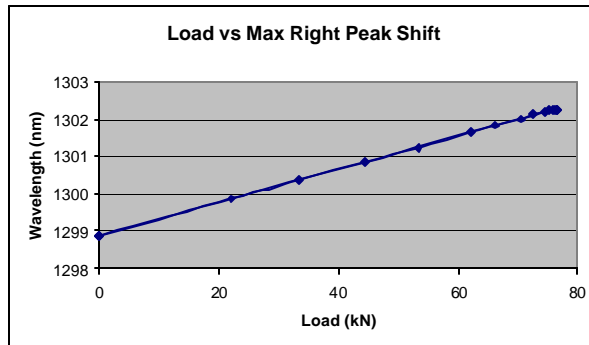
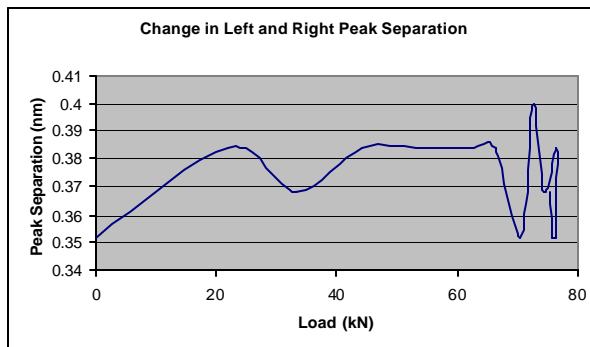
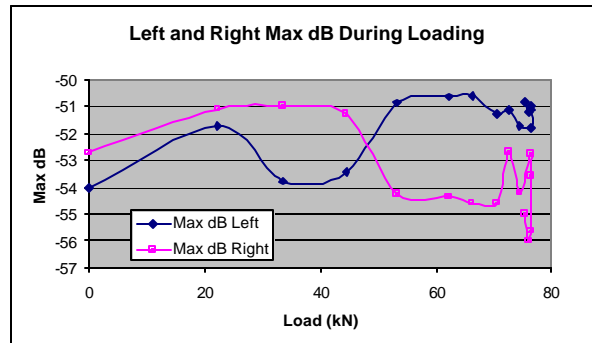
Figure 7. C2 Wavelength Output and Peak Data

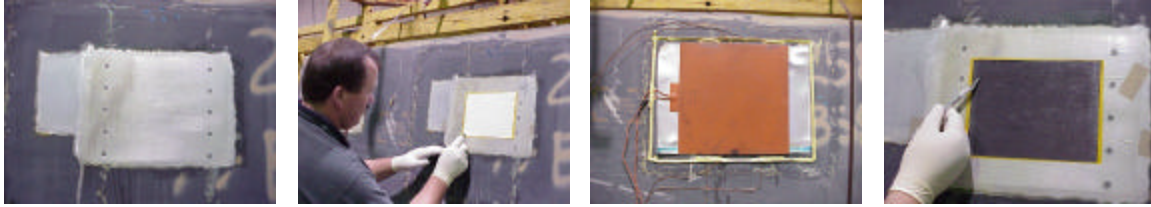
Figure 8. Boron/Epoxy Patch and Sensor Installation on Fuselage Panel

The fuselage panel was mounted on a stand in the vertical position. This enabled the evaluation of installing the sensors in a vertical position. A 23 cm by 23 cm area of the panel, between stiffeners, was chosen for installation of an externally bonded-on boron/epoxy doubler. The aluminum surface was anodized and primed using the Phosphoric Acid Anodizing Containment System (PACS) and BR-127 epoxy primer. The patch was a five-ply unidirectional patch that was 15 cm wide by 20 cm long and was bonded on using FM-73M OST epoxy film adhesive and a heat blanket, vacuum bagged process. Two axial Bragg-grated fiber optic sensors were installed with the patch. One sensor was placed in the bondline and the other sensor was placed under the top layer of the patch. Figures 8 and 9 show the patch installation and a schematic of the sensor placement, respectively.

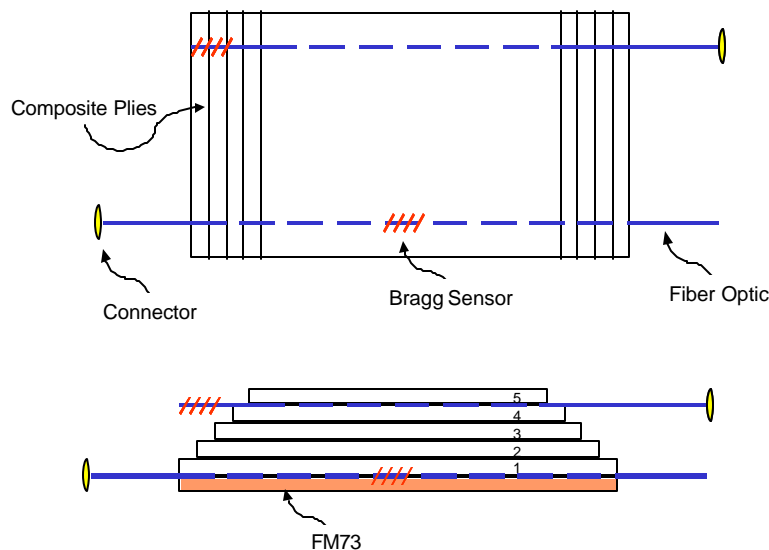
Figure 9. Fuselage Panel Patch and Sensor Installation Schematic

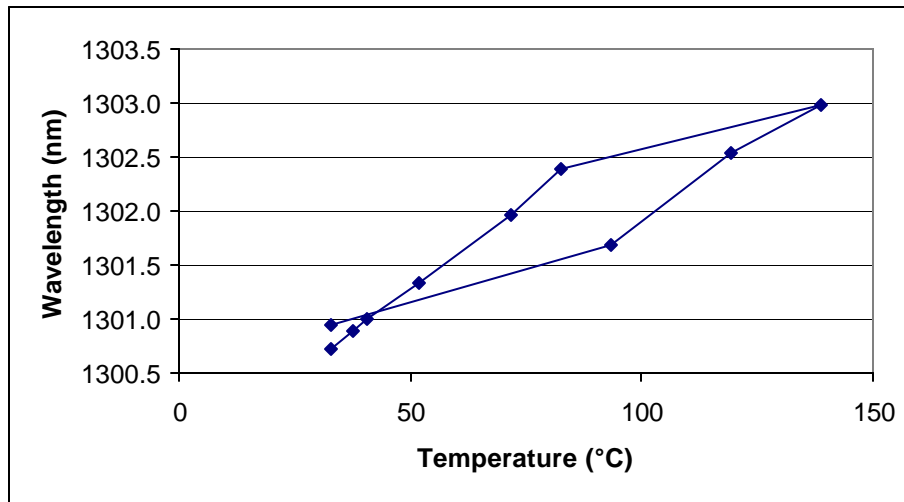
A plot of the maximum wavelength peak and temperature is shown in figure 10. The first measurement at 33°C was not at a steady state temperature. Also, the part heated up rapidly while the cooling down process was much slower. For example, it was approximately 5 seconds between the first (33°C) and second reading (93°C) and it was approximately two minutes between the fifth (83°C) and sixth (72°C) readings. So, between the time of recording data and calling out the temperature, the peak could have shifted on the heating side. This may also be why there appears to be a hysteresis of sorts in the temperature plot.

Figure 10. Fuselage Panel - Wavelength Peaks at Different Temperatures

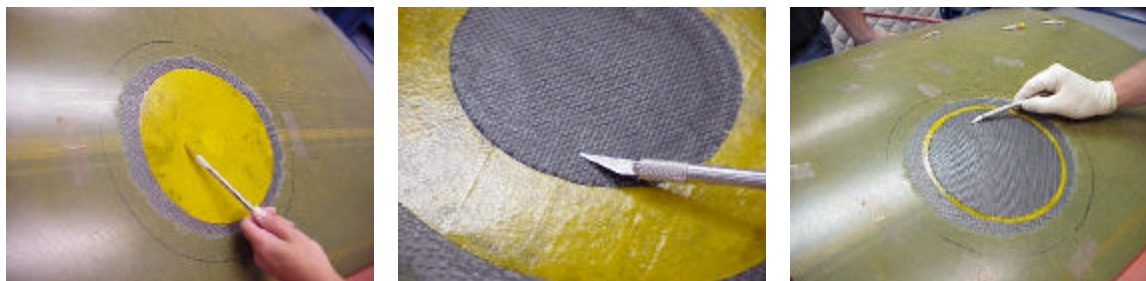
Sensor in Bondline

Sensor Between Plies

Sensor Near Top

Figure 11. Composite Panel Scarfed Patch and Sensor Installation

Three Bragg-grated axial fiber optic sensors were installed in this scarfed patch, one in the bondline and two within the patch. Figures 11 and 12 show the patch and sensor installation and the sensor installation schematic, respectively. Note that the sensors in this patch are installed in different directions to evaluate the ability to distinguish wavelength output differences due to different levels of strain.

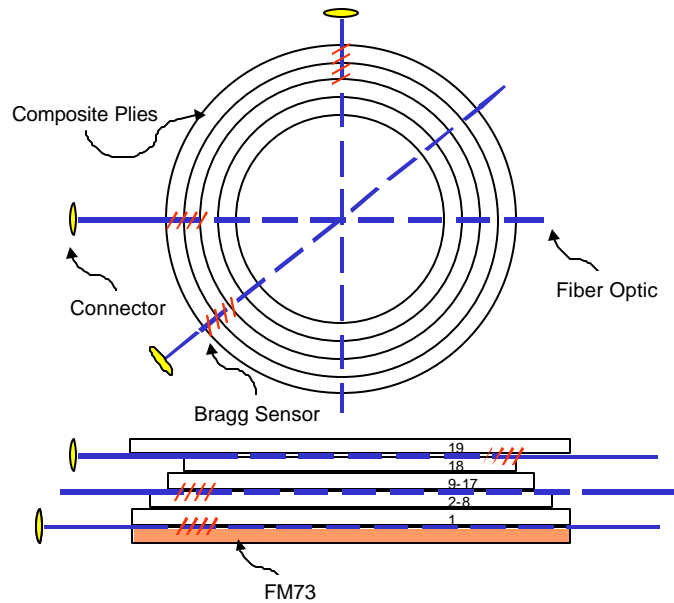
Figure 12. Scarfed Gr/Ep Patch Sensor Installation Schematic

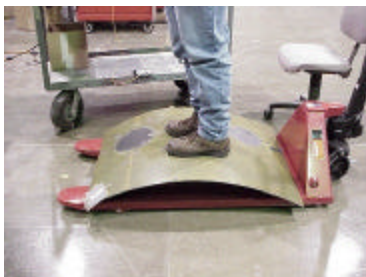
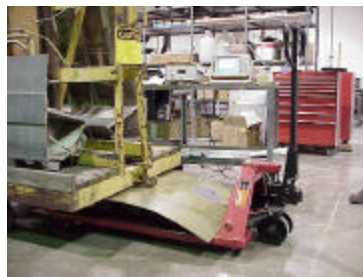
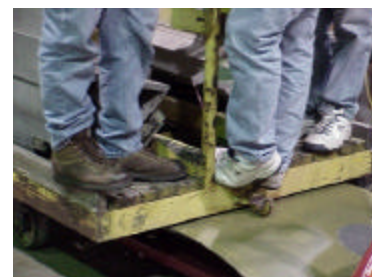
Load 2

Load 3

Load 4

Figure 13. F-22 Panel Loading Conditions

All three sensors (0 deg, 45 deg and 90 deg) survived the installation and curing process. This included overlapping the fiber optics outside of the patch and under the thermal blankets. Data from the sensors were obtained during a series of loading conditions (figure 13) using an OSA with a resolution of 0.05nm. The loading conditions were:

- Load 1: no load;
- Load 2: man standing on top of the part (at ~105 Kg);
- Load 3: pallet jack loading on part while under stand (magnitude unknown);
- Load 4: pallet jack loading plus three men (~320 Kg extra); and
- Load 5: no load/residual (to verify return to initial condition).

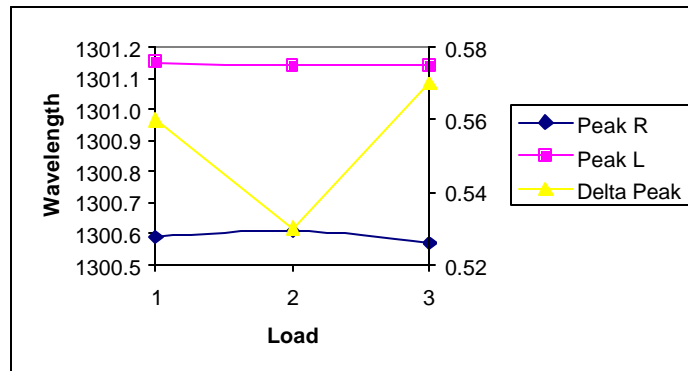
Figure 14. F-22 Panel, 0 Degree Sensor Data

Data from the three sensors in the patch all have the same general trend, however, there are differences in the output patterns due to slightly different loading conditions and directions. Plots of the results of the three sensors and the five loading conditions are contained in Figures 14, 15 and 16. All the sensors shifted to the left as the increasingly heavier loads were applied. There was also movement between the two peaks for each sensor, indicating a change in shear loading as well. The 0-degree sensor was broken through user error before the final two loads

could be applied, so no data could be recorded for loads 4 and 5. Note that the left axis is wavelength and the right axis is change in wavelength.

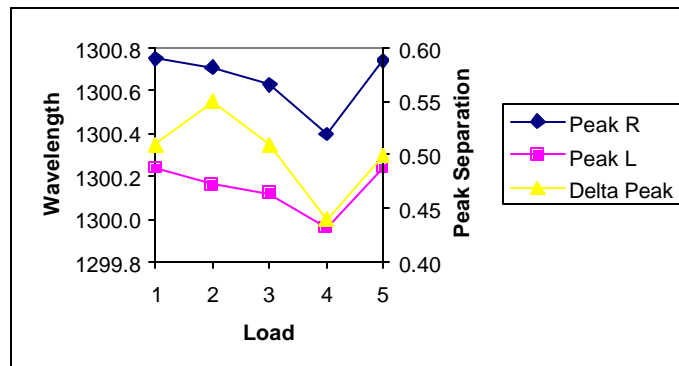
Figure 15. F-22 Panel, 90 Degree Sensor Data

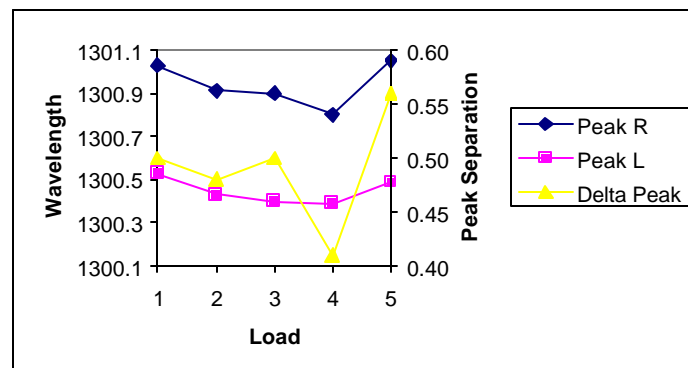
Figure 16. F-22 Panel, 45 Degree Sensor Data
